# Manhole Inspection Summary

Manhole # S19II\_002MH

**Location** Address: **1817 N PULASKI ST**

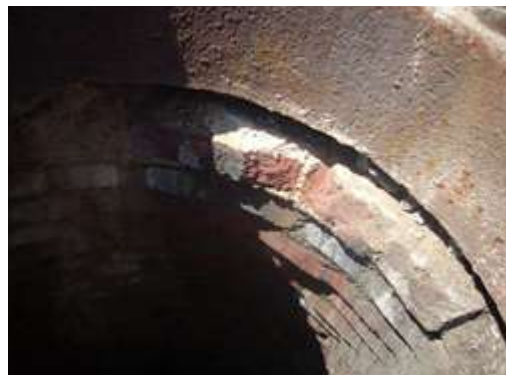
Defect 1

BELOW GRADE - EVIDENCE OF INFILTRATION FROM PONDING OF SURFACE

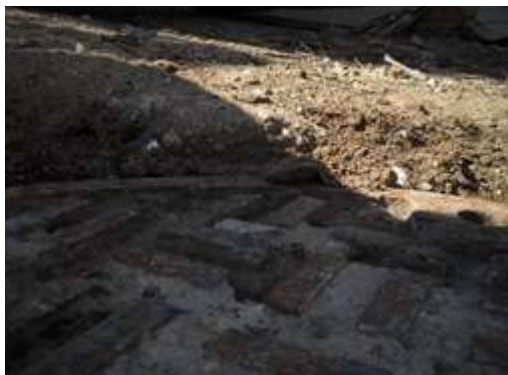
Defect 5

DETERIOATION OF CHIMNEY

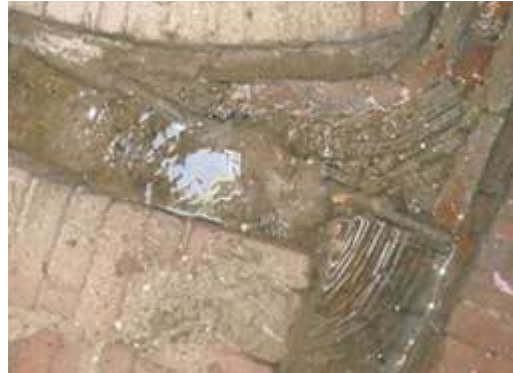
Defect 2

WORN LID
